Parkside Elementary School Addition & Renovation
North St. Francois County R-1 School District
Progress Update Report, December 2009

Parkside Elementary School Addition/Renovation
December 2009 Construction Photos

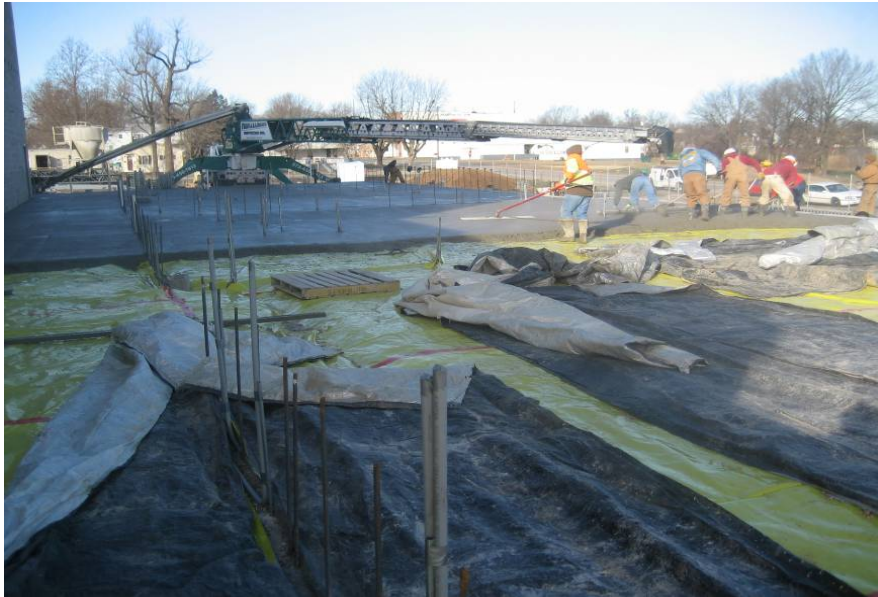
Pouring Fine Arts area slab. Blankets are removed as pour progressed

The stage area was backfilled and the stage slab has been poured along with the step portion. In the Fine Arts section of the building, concrete work has been completed; interior load bearing footings were dug and poured, rock base installed, electric ground rough in completed and slab poured and finished. Insulated blankets were brought out early in the month to keep ground from freezing until poured and then used to protect slab from freezing as it cured.

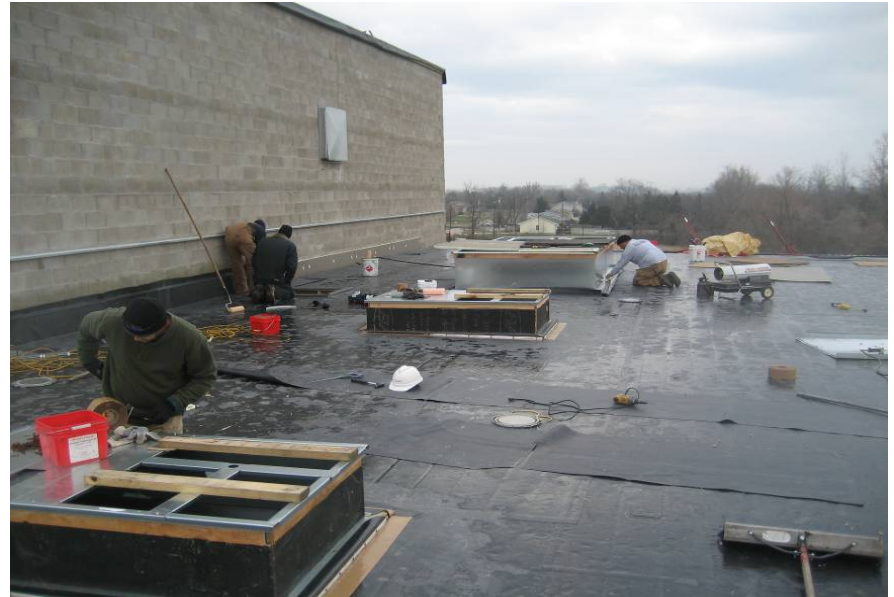
Installing roofing over gym classroom area

Steel joist, roof deck, perimeter angles at the roof, and roofing have been installed over the gym and gym classroom area; the contractor has constructed temporary closures of all exterior opening at the gym and gym classroom so interior masonry work can be done on cold weather days, ductwork can be installed, plumbing above the floor rough in of DWV and water piping can be done, and electrical ceiling rough in done along with pulling of wiring to the area.

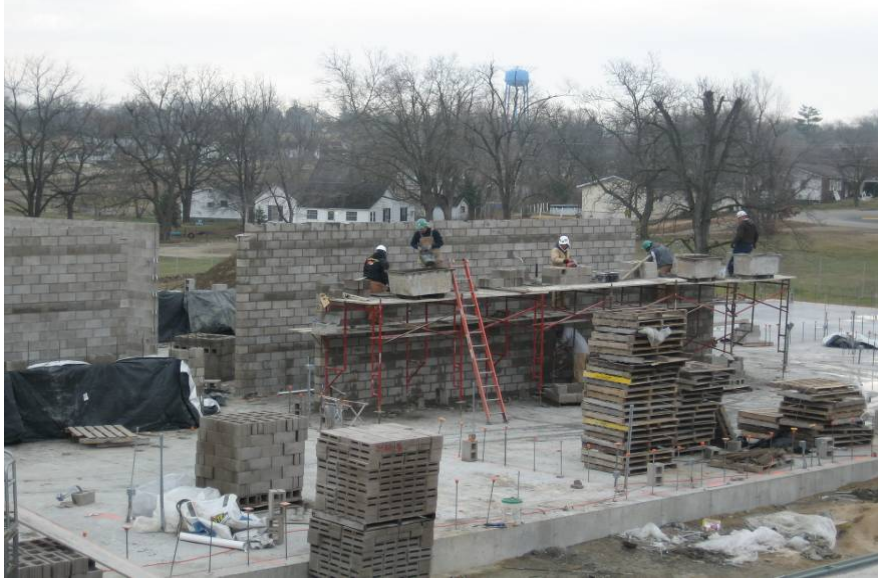
Progress on classroom wing load bearing walls

Masonry work is progressing well despite losing nine (9) days of the 22 work days to cold weather or rain. The Office/Administration area load bearing and shear walls were completed; the classroom wing north portion is about two (2) days from completion of all load bearing and shear walls; the south portion of the classroom wing is about 1/3 complete; work is on going on the stage area walls and the west exterior building elevation walls.

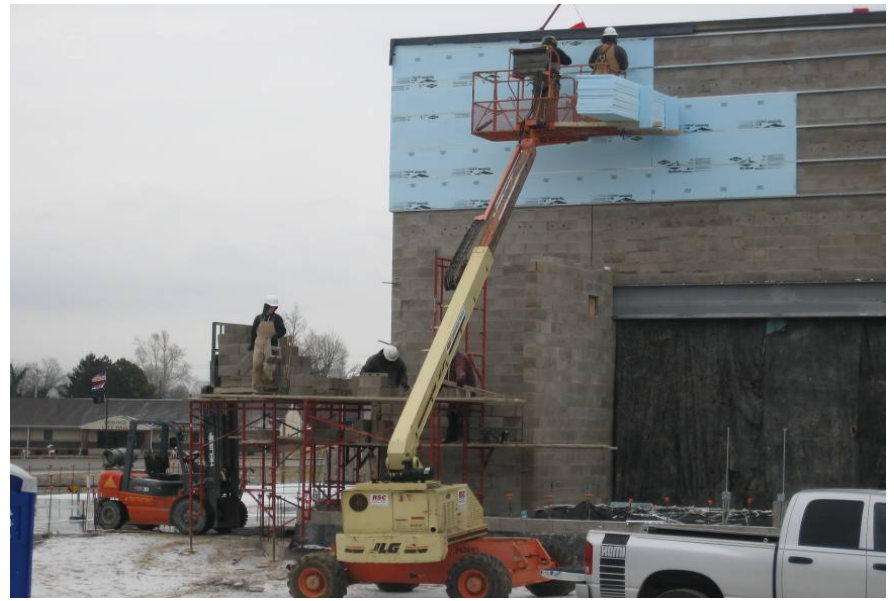
December 30th - Snow falling as masons work on CMU walls at the west elevation of building. Carpenters install insulation board and "Z"-furring for metal siding.
